Colonial Manor West Apartments C.A., Inc
Fort Lauderdale, FL

Report #: 46382-0
Beginning: January 1, 2024
Expires: December 31, 2024

RESERVE STUDY
"Full"

March 21, 2023

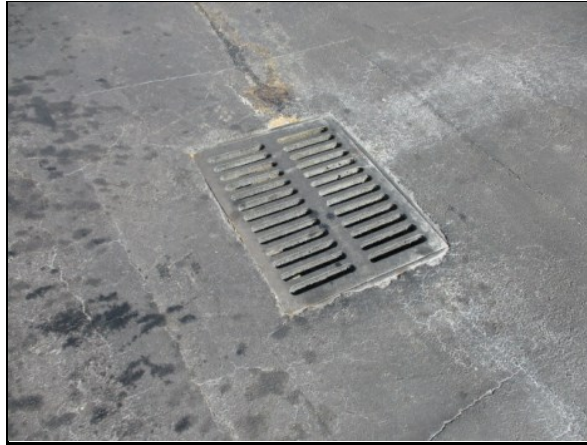
Comp #: 2114 Site Drainage - Inspect/Repair/Cert

Useful Life:
5 years

Remaining Life:
4 years

Lower allowance for inspection, repair,
certification
