Colonial Manor West Apartments C.A., Inc
Fort Lauderdale, FL

Report #: 46382-0
Beginning: January 1, 2024
Expires: December 31, 2024

RESERVE STUDY
"Full"

March 21, 2023

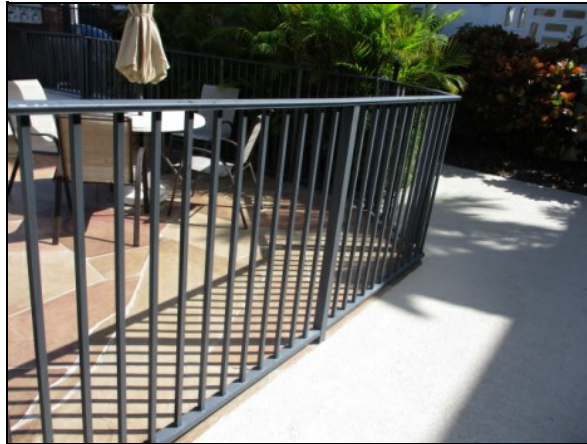
Comp #: 2771 Pool Fence - Replace

Fair condition: Pool fencing determined to be in fair condition typically exhibits some minor to moderate amounts of surface wear and other signs of age, which may include corrosion, loose or unstable pieces/sections or hardware, and/or overgrowth by surrounding vegetation. Overall, appears to be in serviceable but declining condition.

As a routine maintenance item, fence should be inspected regularly and repaired as-needed to ensure safety. Periodically clean with an appropriate cleaner and touch up paint as needed in between regular paint cycles. When evaluating replacements, be sure to comply with any applicable building codes. Gates and locks should be inspected to make sure they close and lock properly. Faulty perimeter around a pool area can expose a development to significant liability risk. When possible, replacement should be coordinated with other projects, such as pool deck projects, other fencing/railing work, etc.

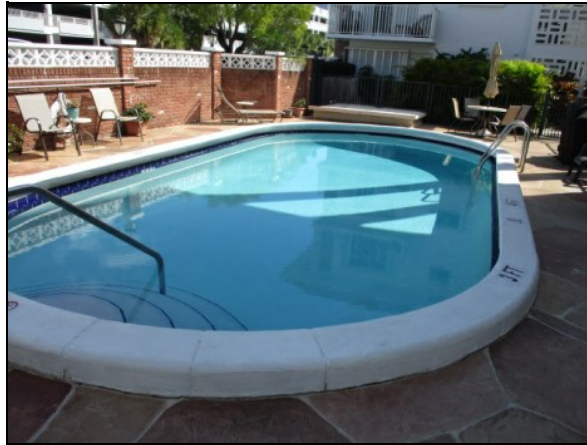
Fair condition: Swimming pools determined to be in fair condition typically exhibit some color fade/discoloration, and roughening of the surface, often more noticeable in the shallow areas and/or at steps. Waterline tiles are in fair condition. Generally believed to be aging normally.

Pool resurfacing will restore the aesthetic quality of the pool while protecting the actual concrete shell of the pool from deterioration. While drained for resurfacing, any other repairs to lighting, handrails, stairs, ladders, etc. should be conducted as needed. This type of project is best suited for slow/offseason to minimize downtime during periods when pool is used heavily. Should be expected at the approximate interval shown below; in some cases, schedule may need to be accelerated due to improper chemical balances or aesthetic preferences of the Client.

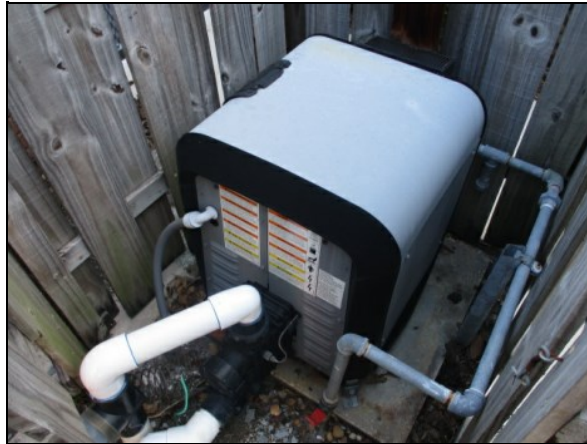
Comp #: 2781 Pool Heater - Replace

Pool vendor should inspect heater regularly to ensure proper function, identify any required repairs, etc. Internal components were not analyzed during our site inspection. Many clients choose not to heat their pools year-round, which can prolong the life of the heater while reducing energy costs. When replacement models are being evaluated, we recommend considering high efficiency models which may have a higher initial cost but will ultimately be less expensive due to reduced energy usage. Minimal or no subjective/aesthetic value for pool and spa equipment. Useful life is based primarily on normal expectations for service/performance life in this location. Unless otherwise noted, remaining useful life expectancy is based primarily on original installation or last replacement/purchase date, our experience with similar systems/components, and assuming normal amount of usage and good preventive maintenance.

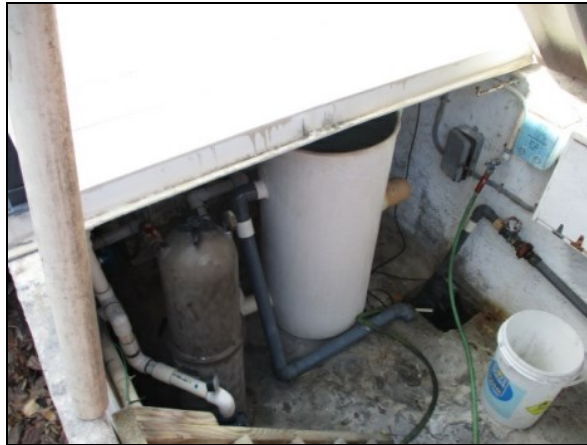
Comp #: 2787 Pool Equipment - Repair/Replace

Minimal or no subjective/aesthetic value for pool and spa equipment. Pool and spa pumps, filters, chemical feeders, and other miscellaneous equipment can be repaired or replaced for relatively low cost in most cases. Due to varying ages and/or information provided during this inspection, comprehensive replacement of all equipment at once is not anticipated. Thus, this component represents a "supplemental" allowance to repair, rebuild, and/or replace equipment as needed. Remaining useful life has been adjusted based on available visual condition, manufacture dates (if available), and/or Client cost history provided. The Client should continually track relevant repair/replacement expenses and report them during future Reserve Study updates. This component should then be re-evaluated based on the most current information available at that time.
